TECHNICAL NOTE 3190

FATIGUE INVESTIGATION OF FULL-SCALE  
TRANSPORT-AIRPLANE WINGS

SUMMARY OF CONSTANT-AMPLITUDE TESTS THROUGH 1953

By M. J. McGuigan, Jr., D. F. Bryan, and R. E. Whaley

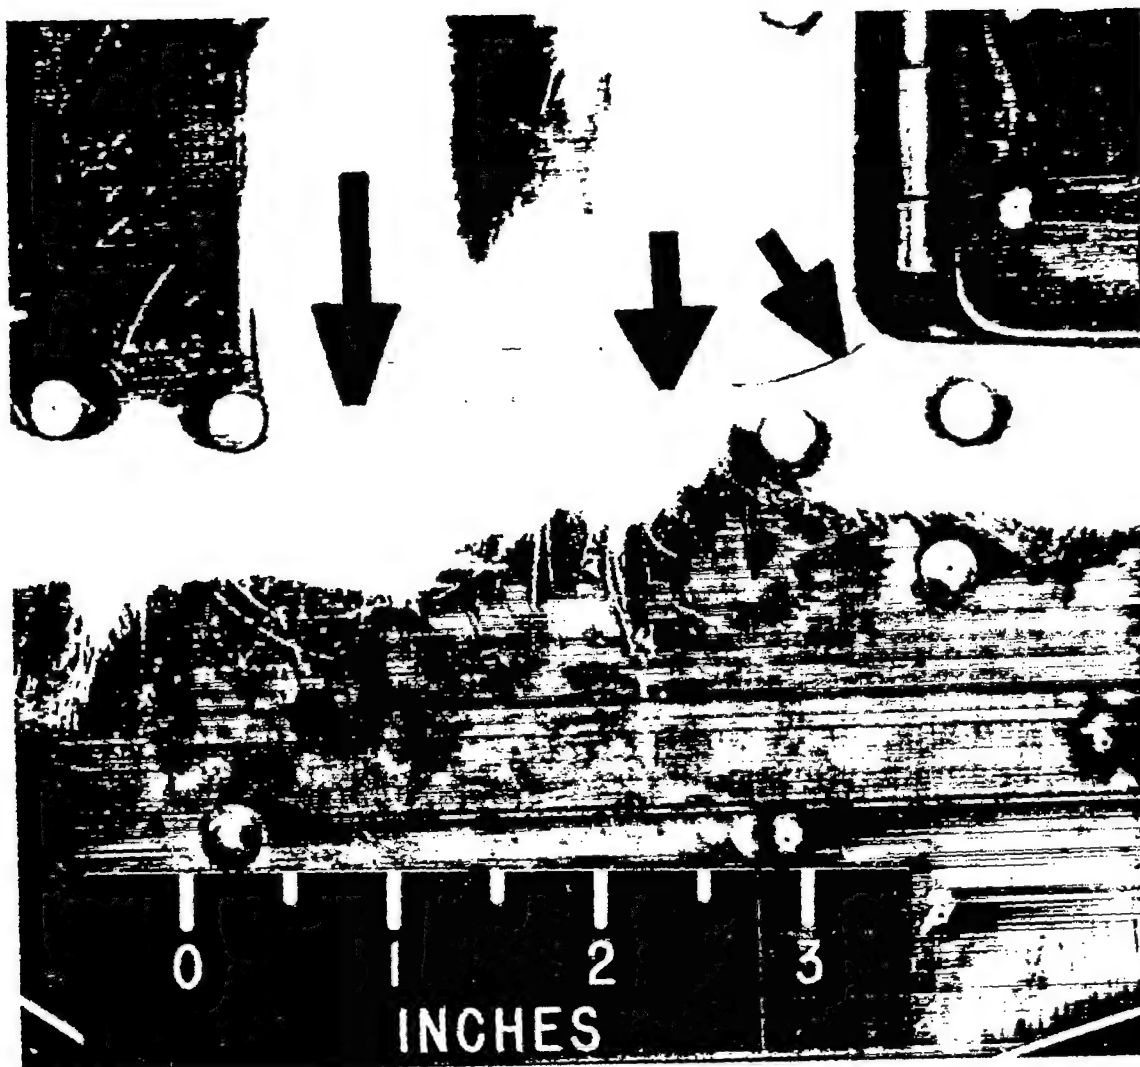
L-77922.4

The type I failures originated in the corners of inspection cutouts B, F, G, and H, and examples are shown in figures 6(a) and 6(b). These cutouts had non-load-carrying covers and were all at span station 214. Most of the failures occurred in the vicinity of the spar at the 30-percent-chord position, which was the most highly stressed region as indicated by the chordwise stress-distribution survey at this station. Since span station 214 contained numerous cutouts, doublers, and other discontinuities and therefore yielded an irregular stress distribution, another chordwise survey was made at span station 235, which was the nearest station that was free of these discontinuities. The gages used in these surveys were oriented so as to measure the strain in a spanwise direction. The results of these surveys are presented in figure 8, along with a cross section of the tension surface at span station 214. This figure indicates that for both of these stations the highest stress occurs in the vicinity of the 30-percent spar.

(a) Type I failure at forward outboard corner of inspection cutout F.
